**A Dendroarcheological Analysis of the Burpee-Bridges House,
Sheffield, New Brunswick**

Amanda B. Young, Ben E. Phillips and Colin P. Laroque
MAD Lab Report 2009-02
Mount Allison Dendrochronology Laboratory,
Department of Geography and Environment,
Mount Allison University
February 24, 2009

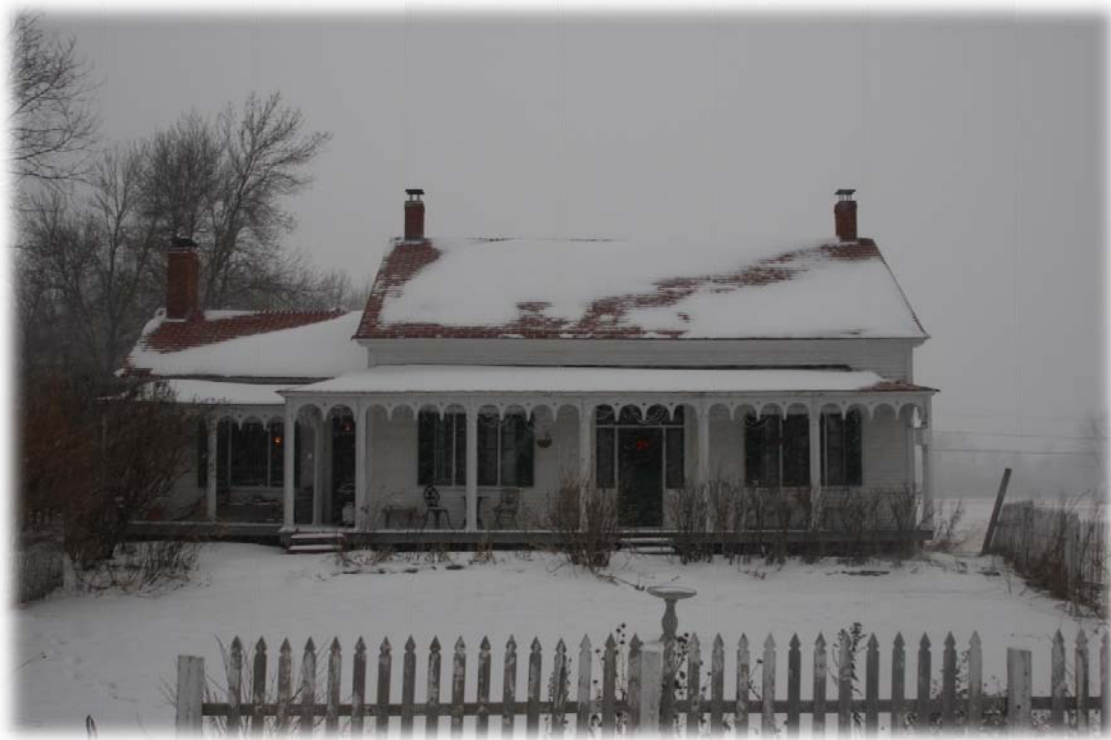
Figure 1. Burpee-Bridges House, Sheffield, NB.

The Burpee-Bridges house is a designated provincial historical site, recognized for its architecture and its name sakes. The house is known as a two story Georgian/ Picturesque House (Figure 1) (Canada's Historic Places 2009). The Mount Allison University Dendrochronology Laboratory (MAD Lab) sampled the house in December of 2008 via the request from the owner Richard Hornsby and from the request of the provincial government through Carlo Laforge. The Burpee-Bridges house is thought to have been constructed soon after expulsion of the Acadians when an American group of settlers came to the Sheffield area.

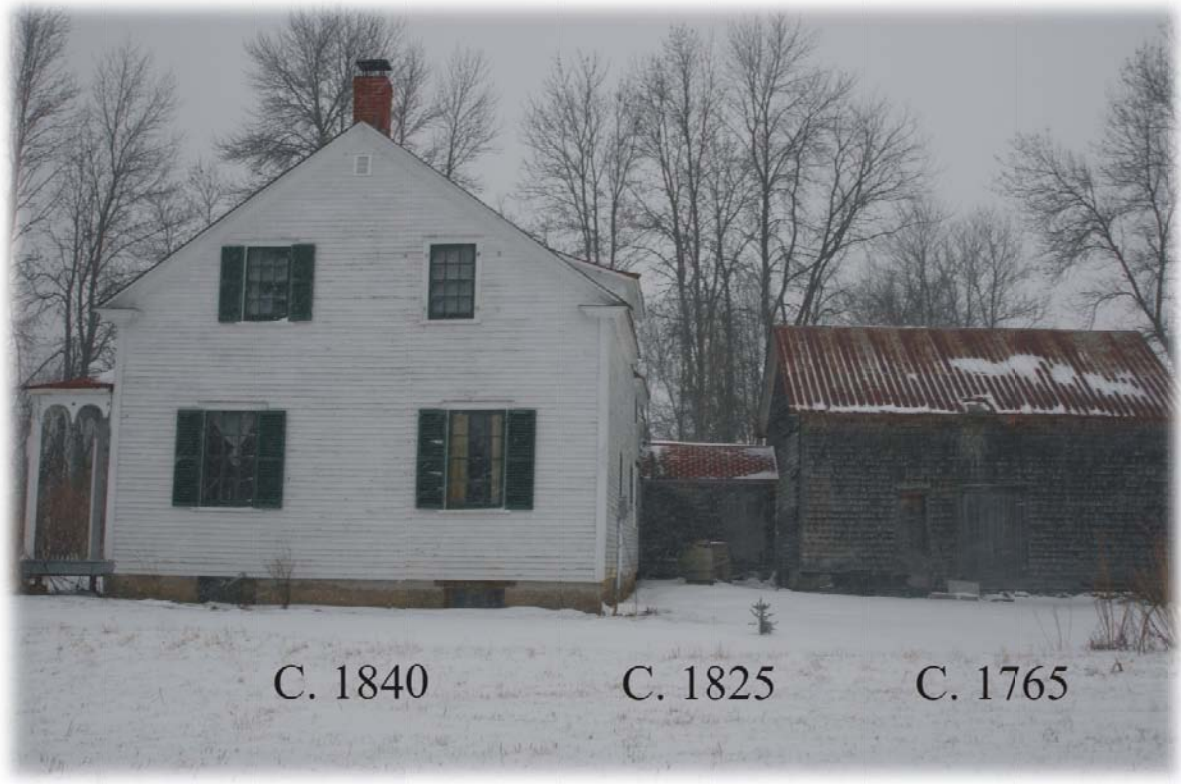
Figure 2. Side view of the Burpee-Bridges House in late 2008, with the annex and barn illustrated along with suggested construction dates of each section.

The house is thought to have gone through a number of different states of construction (Figure 2). The initial structure was the barn (c.1765), and it is believed that the family lived in the structure initially due to a section of the structure that is partitioned off with lathe and plaster siding (C. Laforge. Pers. Comm.). The second section of the house to be built was the annex between the barn and the newly built old kitchen (c.1825) (C. Laforge. Pers. Comm.). The remaining portion of the house was built in the 1840s with further renovations in the 1880s. A number of boards (especially floor and sills) were replaced after a 1973 flood (Canada's Historic Places 2009).

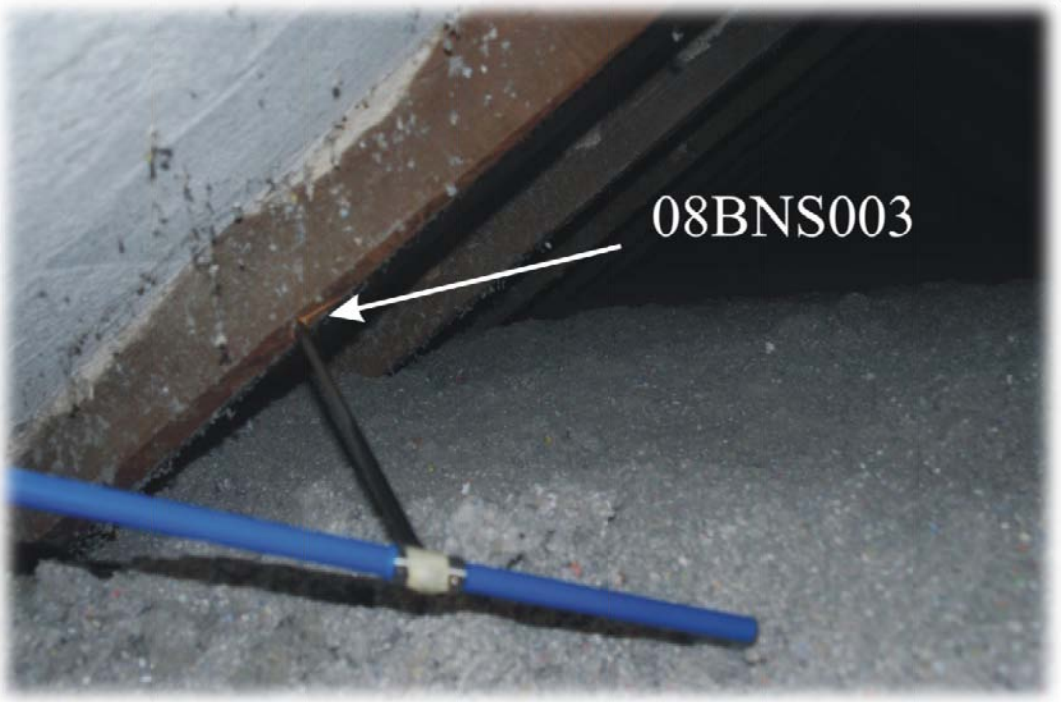
Figure 3. Sample 08BNS003 taken from the attic.

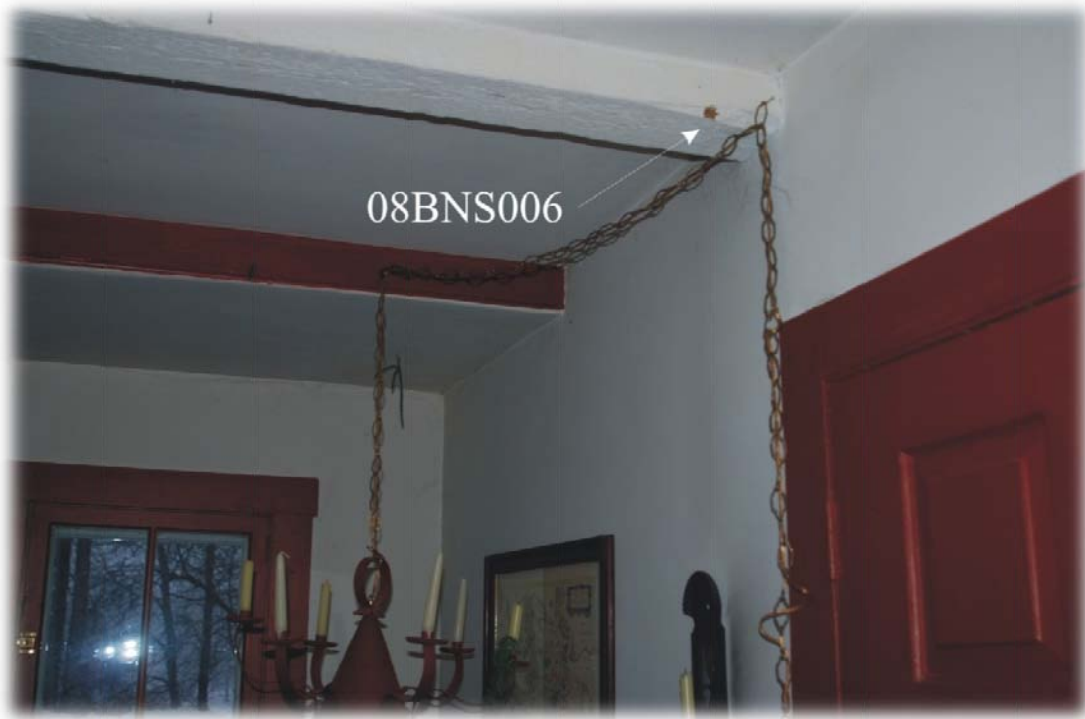
Figure 4. Sample 08BNS006 from a beam near the back door connecting to the annex breezeway from the room with the fireplace.

floor joist (08BNS006) and the corner post from the closet next to the fireplace (08BNS004/5) were both cut in 1846/7. For this evidence to work well in the existing Burpee-Bridges house story, new material would have had to be added to the old structure when the house addition was made, or the age of the old section of the house may need to be upgraded.

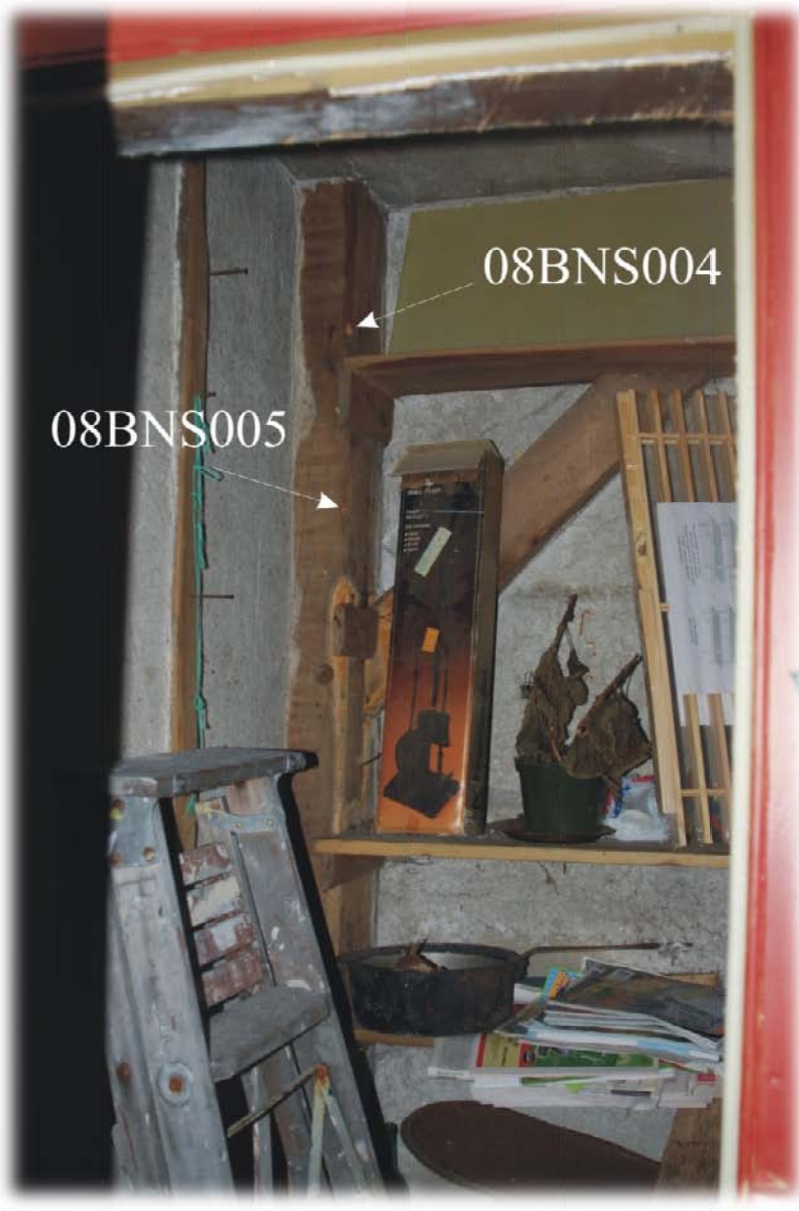
Figure 5. Samples 08BNS004/005 in the old kitchen wood closet next to the fireplace, both cores were taken from the same beam.

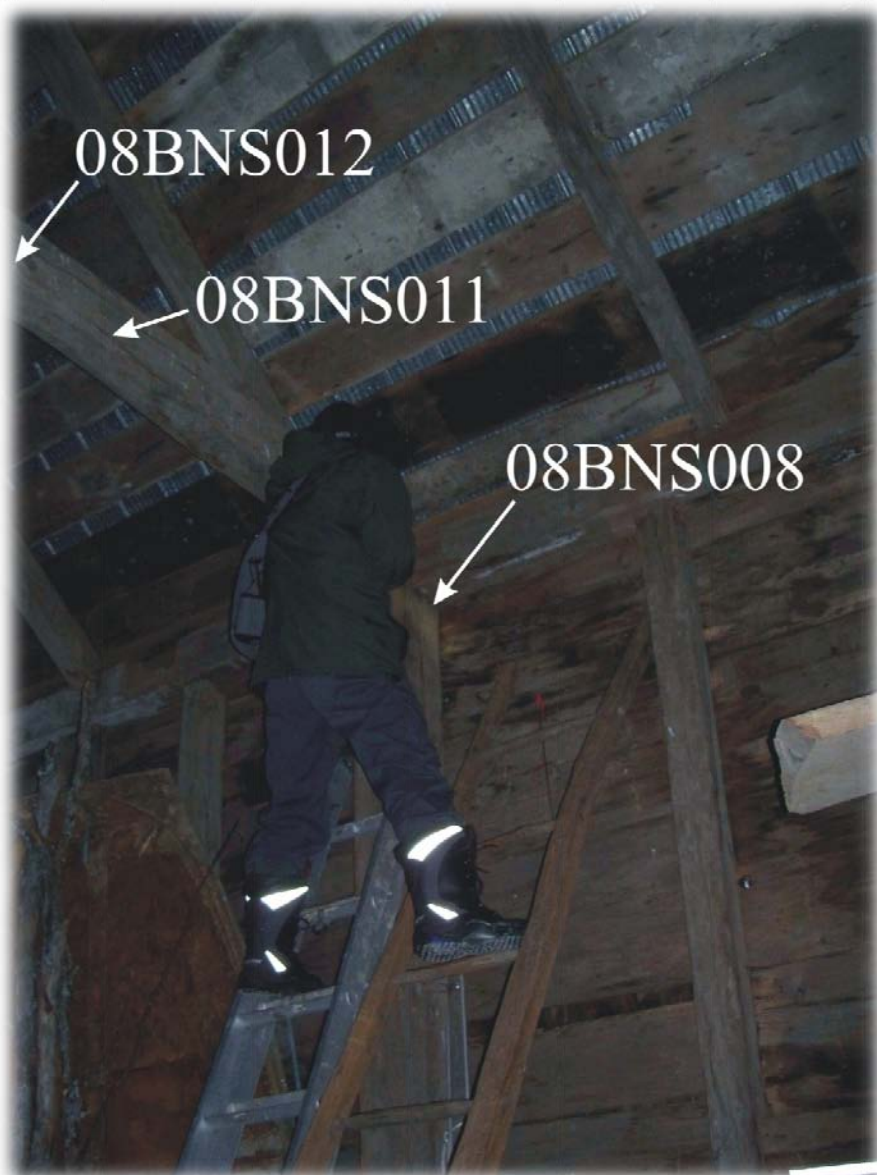
Figure 6. Sample 08BNS008 being taken from a large vertical beam in the barn. Samples 08BNS011 and 08BNS12 were taken from the large horizontal beam above 08BNS008.

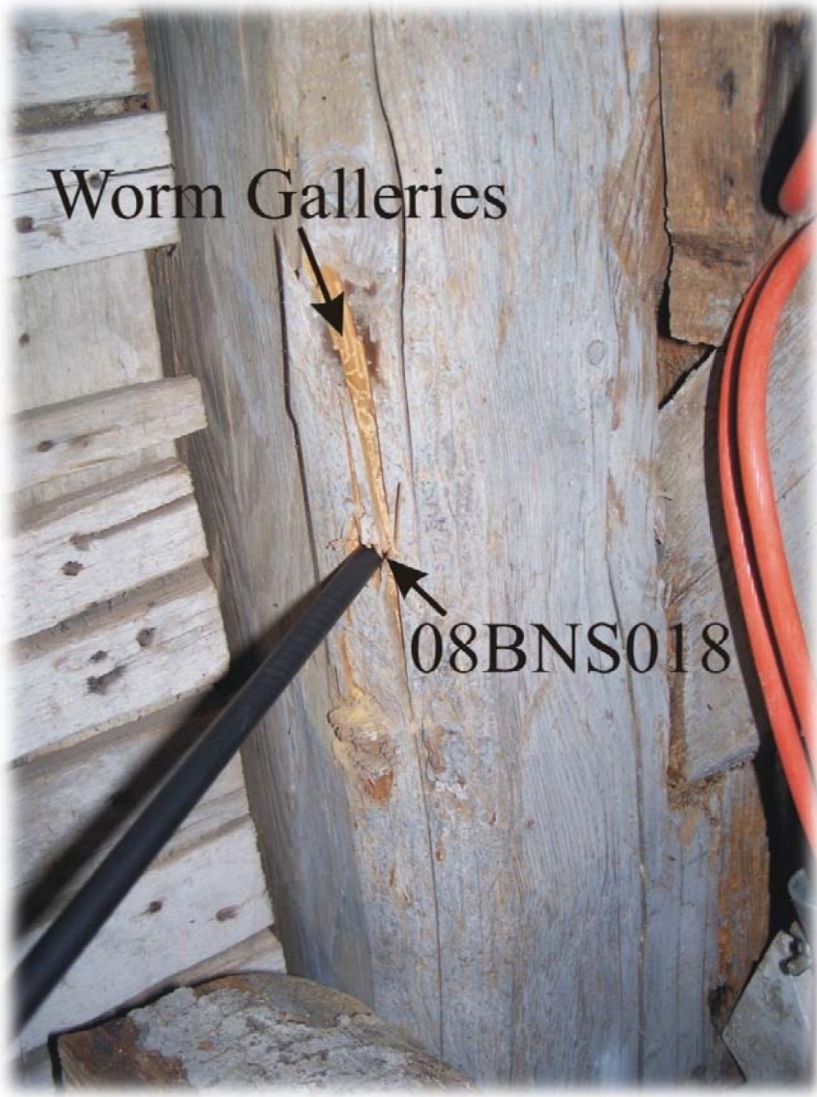
Figure 7. Sample 08BNS018 being taken from a vertical beam in the barn near the lathe and plaster section. Worm galleries near the sampling point signify that the bark/wood interface was present for this sample.

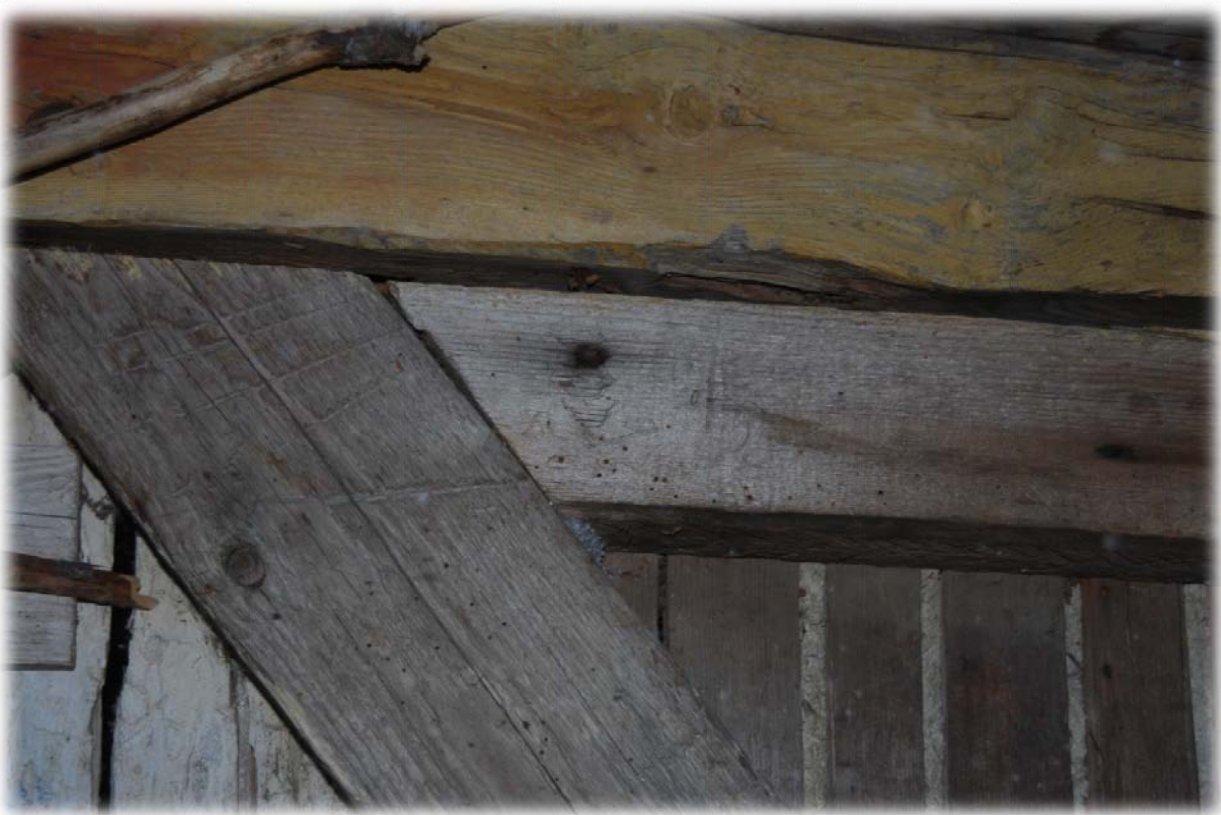
Figure 10. Photo of potentially recycled wood. The diagonal beam has roman numerals on it that do not match to either of the beams it is attached. Roman numerals are typically found on early post and beam structures.

During initial observations of the house and barn, there appeared to be a good quantity and quality of beam material for a chronology to be created. However, once coring began in the barn, a high level of rot was encountered making sampling considerably more difficult. During the overall assessment, a number of beams in the barn were seen that did not fit well into their mortise and tenon joints. These joints almost always fit snugly in buildings, but in the barn many did not or had open mortise joints with no adjoining beam. This indicated that the barn was probably created using recycled wood. The recycled wood could have come from anywhere, and from multiple structures. There were roman numerals found on a number of beams joints that did not line up with partner numerals on the adjoining pieces. Roman numerals are typically

found on both sides of the joint in early post and beam structures, thus some of the beams in the barn are not properly matched and give more evidence for the recycled wood theory (Figure 10).

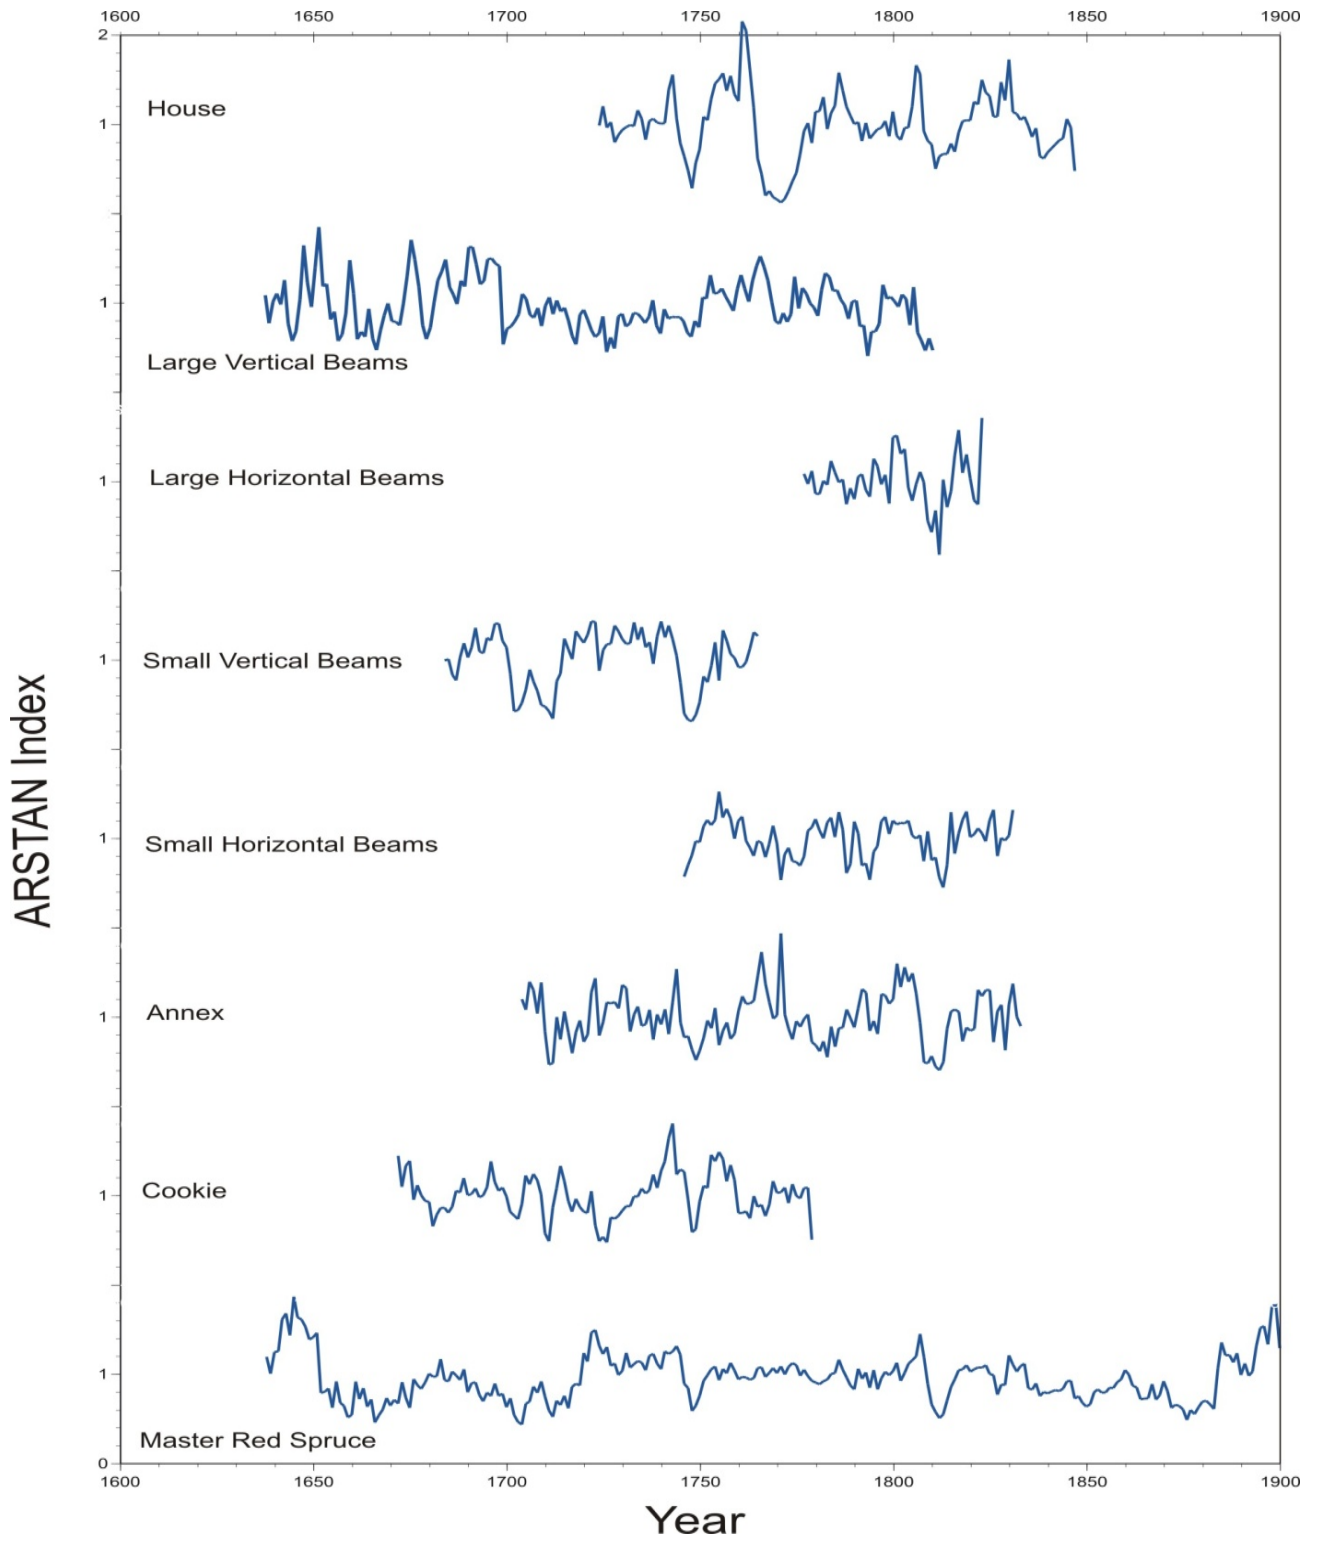
Figure 11. A comparison of the master red spruce chronology and the floating chronologies for the different sections of the structures.

The samples from the Burpee-Bridges house had a variety of ages (Table 1, Figure 11). The house samples dated to 1846/47. There was only one sample from the annex and it was not of the highest quality but it dated to 1833. The barn had a variety of ages of wood from the mid-1700s to early-1800s. There were four large vertical beams dated and they had the most variation in age from 1782-1811. Two samples were taken from one large horizontal beam which dated to 1824. The small vertical beams came from a section of the barn where there were two levels or stories, these beams dated back to 1762-67. The small horizontal beams were the support beams for the second story; they dated from 1824-31. In the barn there was additionally a small cookie taken from one of the large horizontal beams that ran along the side of the building, this sample dated from 1779. The overall correlation within the plot was significant at 0.335. The dated samples matched well to the master red spruce chronology as illustrated in Figure 12.

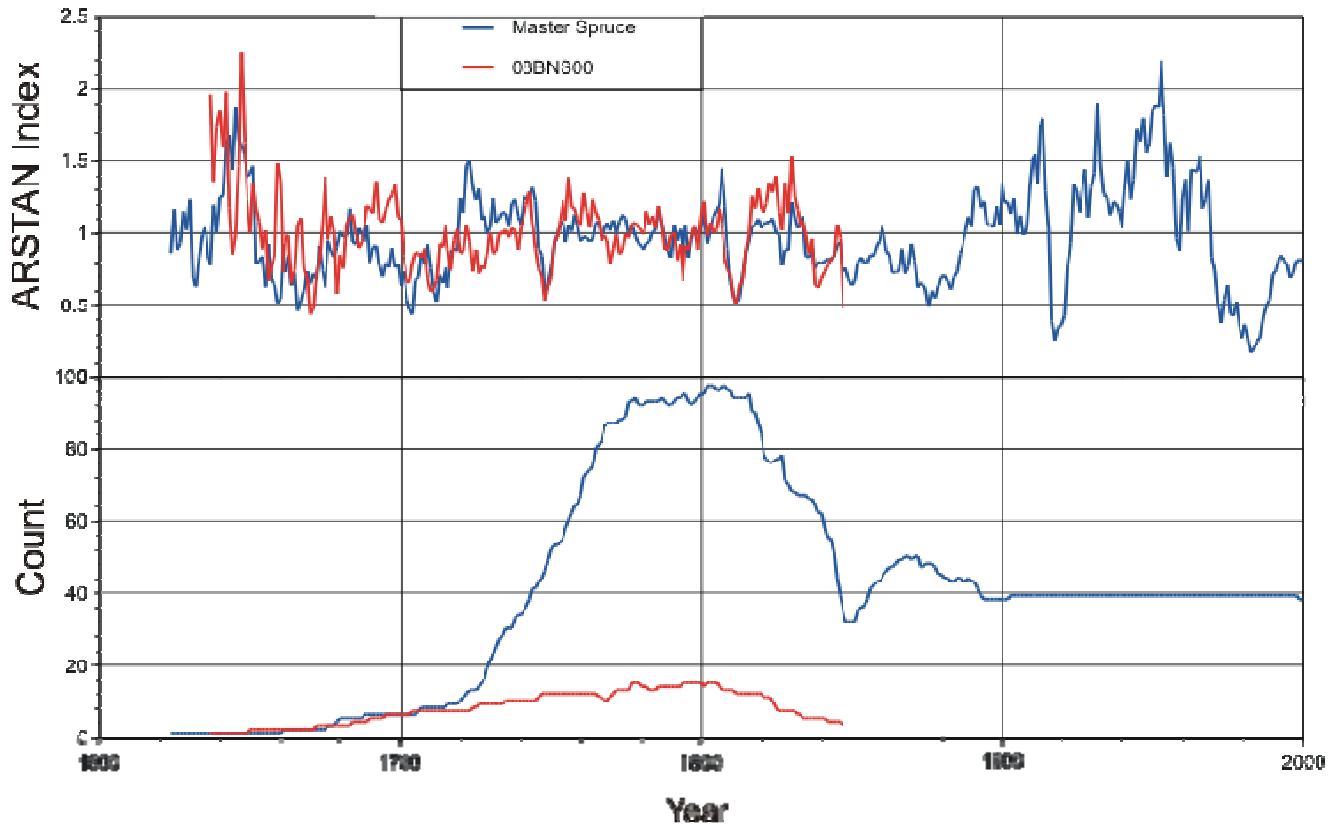
Figure 12. Comparison between the master red spruce chronology and the floating chronology, with the the sampling depth illustrated.

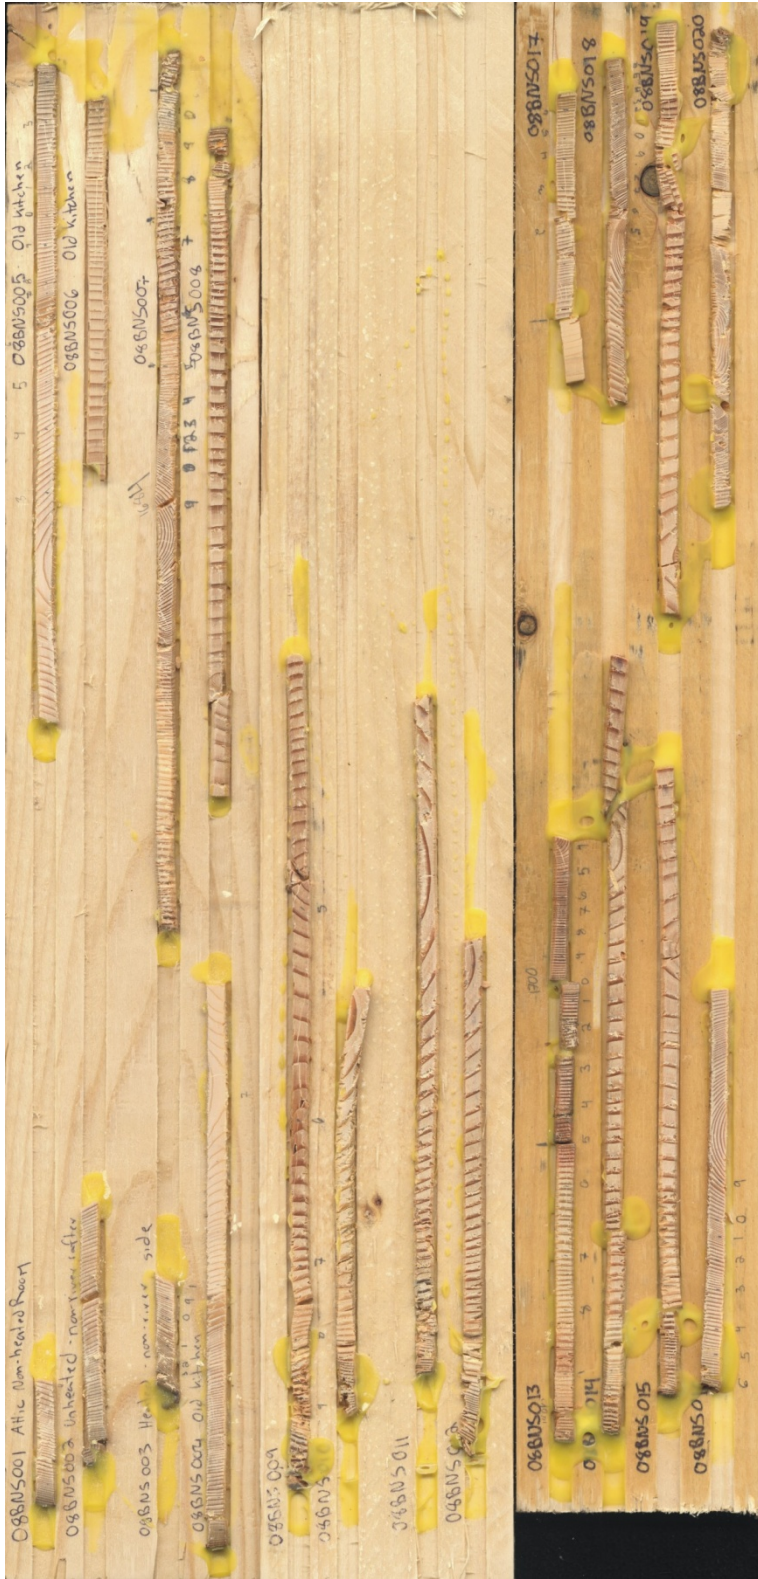
Appendix 1. Scanned samples mounted on boards for stability.

Samples were processed in the lab by mounting them in slotted mounting boards, then sanding them with progressively finer sand paper (80-400 grit) to bring out the cellular structures and annual rings of the wood. Rings were counted and measured from the bark to the pith (middle) of each core sample using a Velmex measuring system with an accuracy of 0.001mm. Not all the cores were sound (Appendix 1), some of them had broken or rotten pieces in the outermost perimeter of wood.
