**A Dendroarcheological Analysis of the Carriage House at
Government House, Halifax, Nova Scotia**

Georgia Bock and Colin P. Laroque
MAD Lab Report 2011-04
Mount Allison Dendrochronology Laboratory,
Department of Geography and Environment,
Mount Allison University

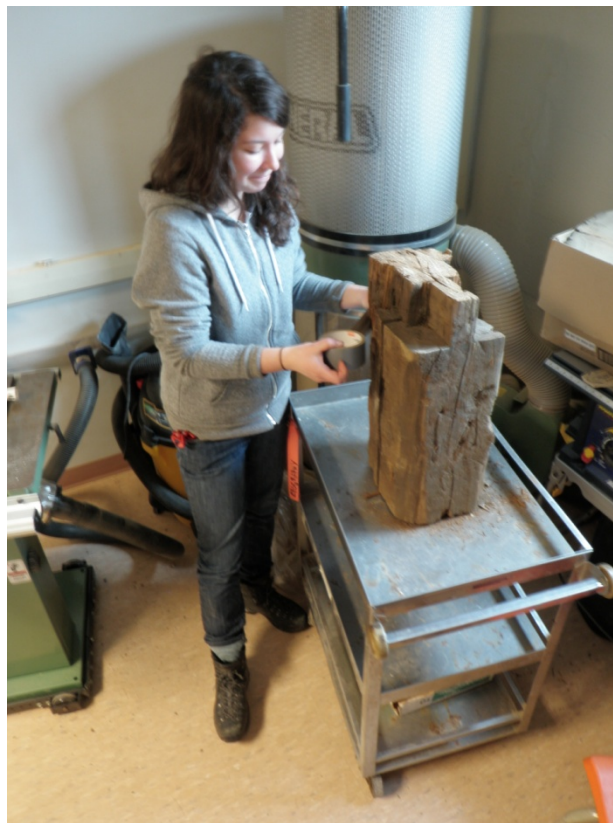
Figure 1. Taping up samples in order to cut out disks. Areas of the sample that contained perimeter wood edges were selected to be used.

The Carriage House is located in Halifax, Nova Scotia at 1451 Barrington St. beside the Government House. The project was assigned the MAD Lab code of 11BD000. In the lab, two disks were cut out of original sample to analyze (labeled 11BD001 and 11BD002) (Figure 1 and 2).

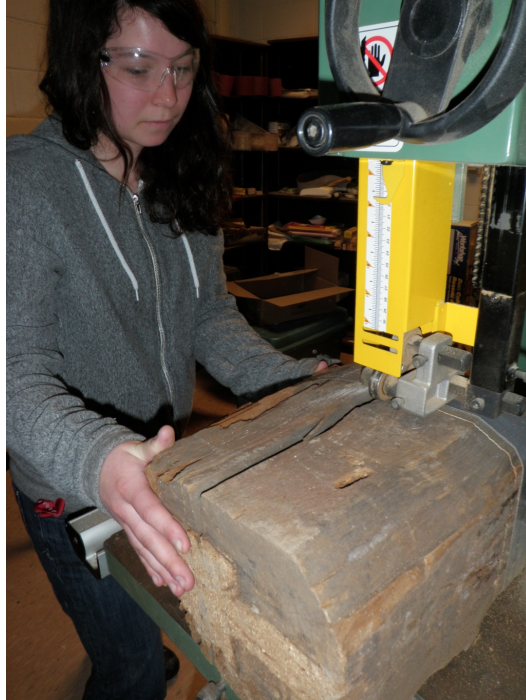
Figure 2: Utilizing the band saw to cut out disk samples.

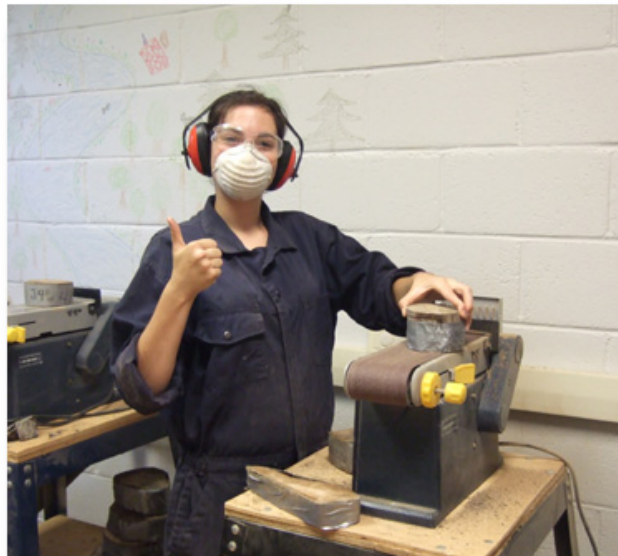
Figure 3: Sanding of the disks took place in the MAD Lab. Sanding allows the details within the ring structures to become visible.

In the lab two disks were sanded with progressively finer sanding paper (40-600 grit) to bring out the cellular structures and annual rings of the wood (Figure 3). Rings were counted and measured along two paths from the pith (middle) of each disc sample using a program called WinDENDRO. Measurement paths were run through the most structurally sound portions of the samples.

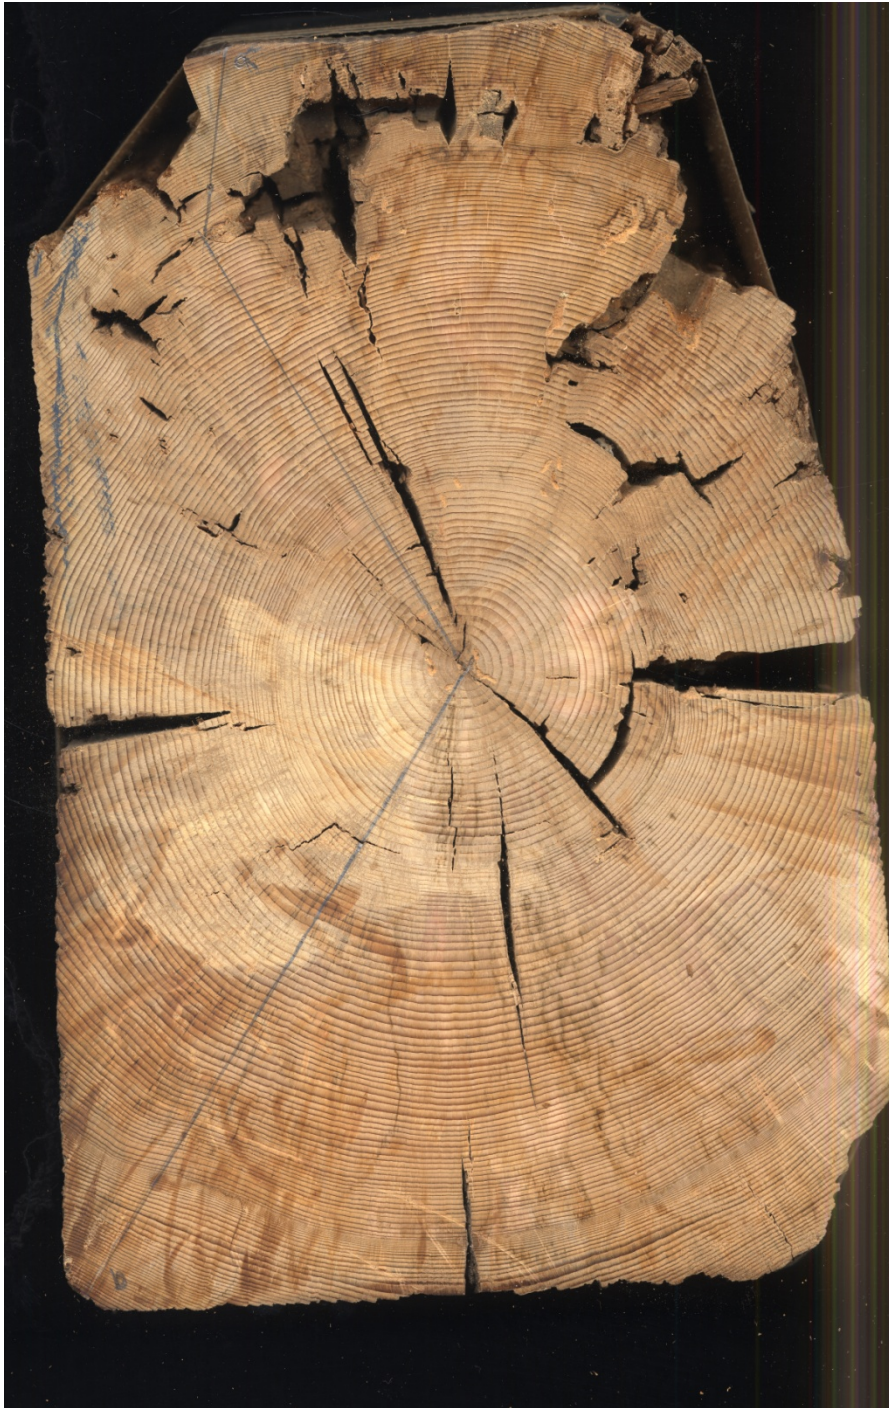
Appendix I – Image of sample disk.

This is the first disk sawed up; it was renamed 11BD001. Two paths (path 1 and 2) were drawn from the center to areas where bark was found around the periphery; this allowed the most rings/years to be accounted for and measured. These paths were then analyzed in WinDENDRO and helped create the floating chronology that was then crossdated with the red spruce master chronology to date this sample of red spruce taken from the Halifax House Carriage Shed.
